Fire Engineering®

Construction Concerns: 9/11 Revisited

September 26, 2016

By Gregory Havel

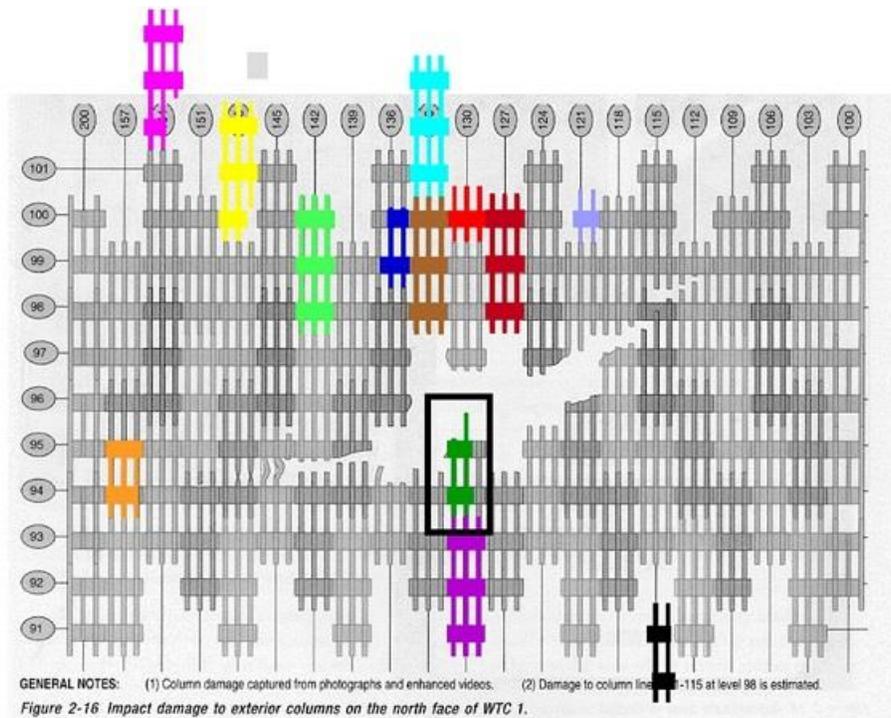
(1) Courtesy of the National Institute of Standards and Technology (NIST) 9/11 reports.

The planes that struck the World Trade Center Twin Towers weighed 100-percent more, carried 100-percent more fuel, and were moving more than 100-percent faster than the planes whose impact the buildings were designed to withstand. The structural steel at the point of impact by the planes was punctured and shredded. In photo 1, the numbers along the left margin indicate floor levels, while the numbers along the top margin indicate column lines on the building's structural plans.

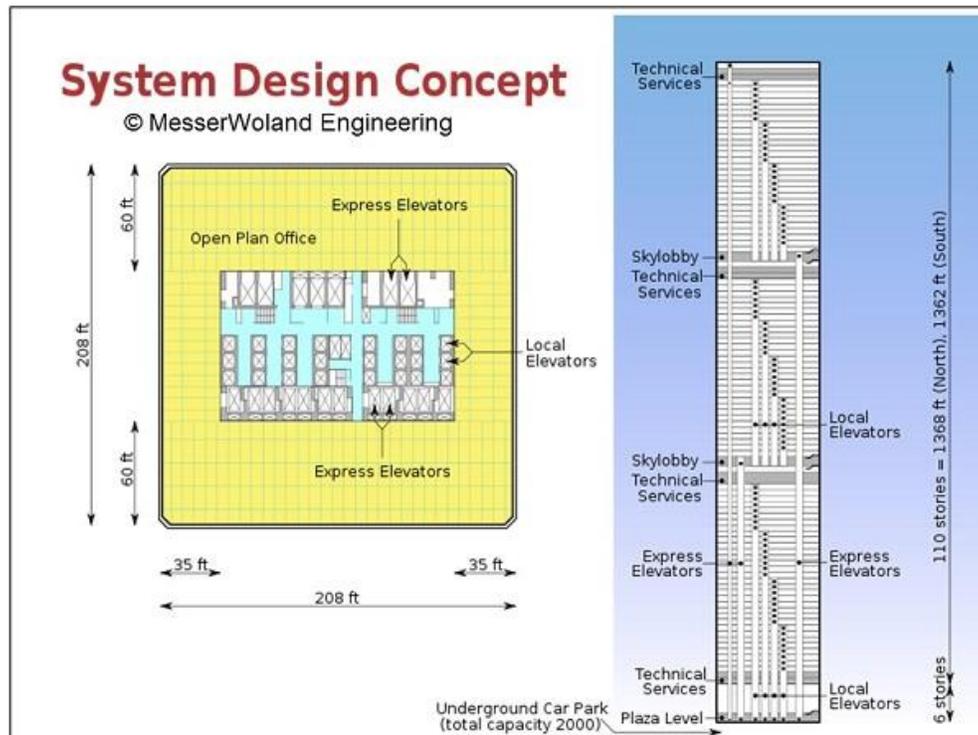
(2) Courtesy of the NIST 9/11 reports.

Photo 2 shows a sample floor layout on the left, including the central core of the building containing utility chases, stairways, and elevators; and the arrangement of express and local elevators serving groups of floor at the right.

Note that although the exterior skin of the building was of structural steel panels and columns that were bolted together, all of the interior partitions were steel stud and gypsum drywall board or thicker gypsum board panels enclosing stairways and elevator hoistways. Gypsum drywall board provides significant fire resistance provided that it is not subjected to mechanical damage before the fire starts. Also note that the floors were of concrete poured on corrugated steel sheets supported by steel bar joists which had been sprayed with fire-resistive insulation similar to that in photo 3. This material provides significant fire resistance, provided that it has not been removed, fallen off, or destroyed by an impact before the fire starts.

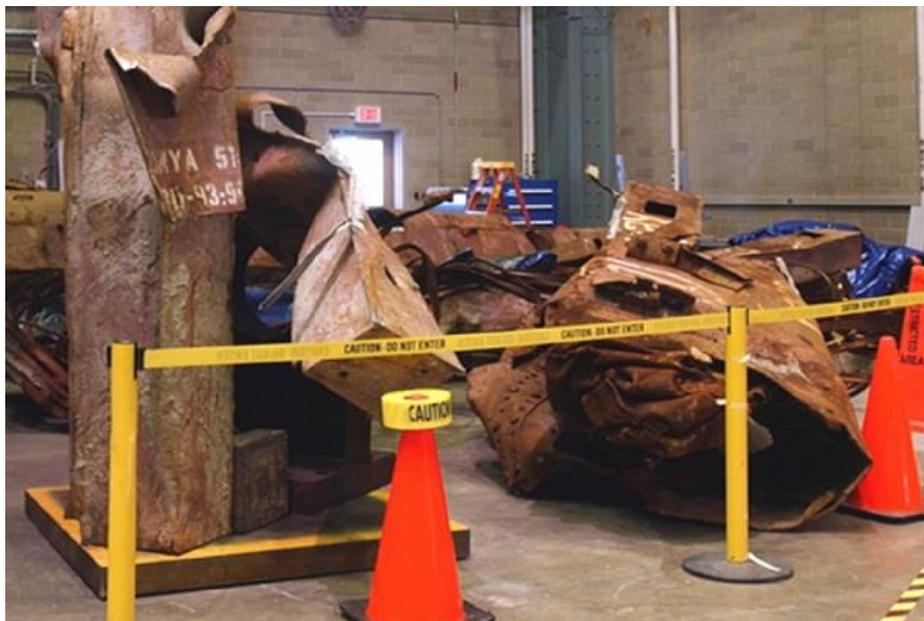
(4) Courtesy of NIST 9/11 reports.

The fireball created by the ignited jet fuel softened and weakened undamaged structural steel and, combined with the forces of the collapsing structures, pressed and twisted it into unrecognizable shapes. In photo 4, the stenciled letters and numbers refer to the column line and floor number for which that structural member was fabricated.

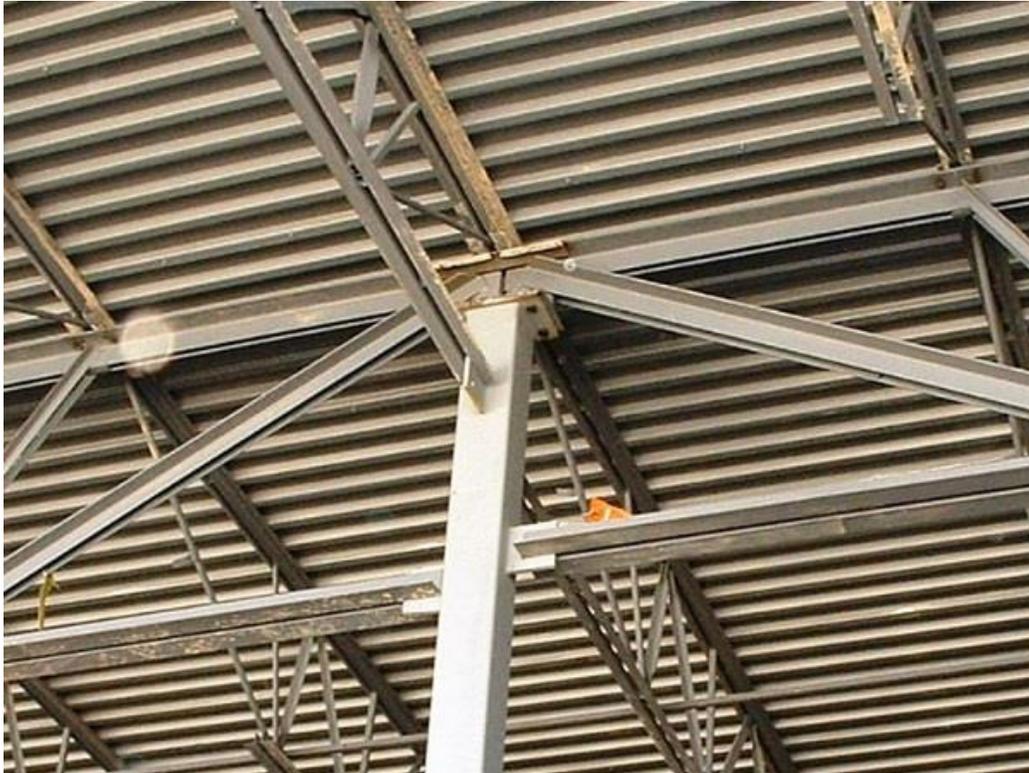
(5)

The impacted buildings were designed using proven principles and connection methods, including the concept of axial loading of columns (the load on the column is carried directly downward from the load through the axis—or center—of a column or load-bearing wall to its foundations and the earth below) and the simple bolted connections of each floor truss to a girder, wall channel, or column. Photo 5 shows the standard two-bolt connection between columns, girders, and bar joists, which has been in use since riveted connections were replaced by bolts, through to the construction of the World Trade Center complex, and into present day. New buildings with structural steel frames, both low- and high-rise, are still being designed with these connections.
