Main Street Memo

Structural Hierarchy & Floor Collapse

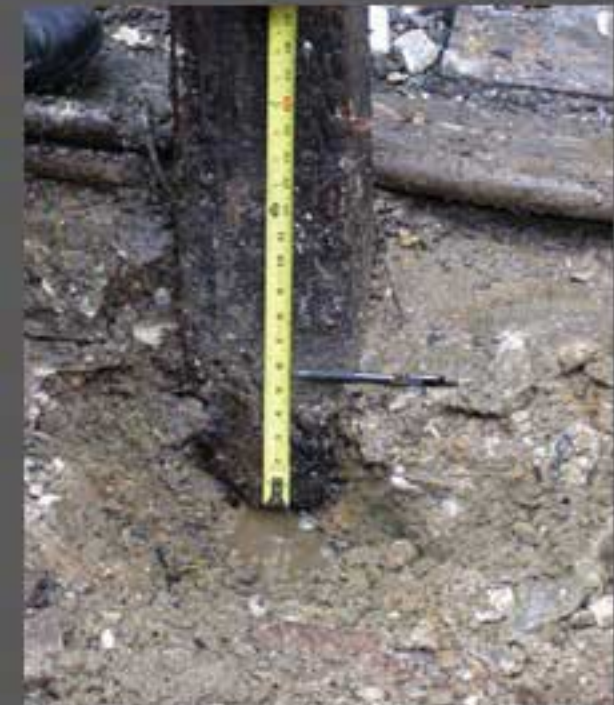
Rot at bottom of column from 1575 Walton Avenue in the Bronx where a collapse claimed the lives of two FDNY members, snap QR to the right for more

While conducting building inspections or walk throughs on your Main Street be sure to check the support columns in the basement
