Fire Engineering®

Construction Concerns: Cantilevered Balconies

Article and photo by Gregory Havel

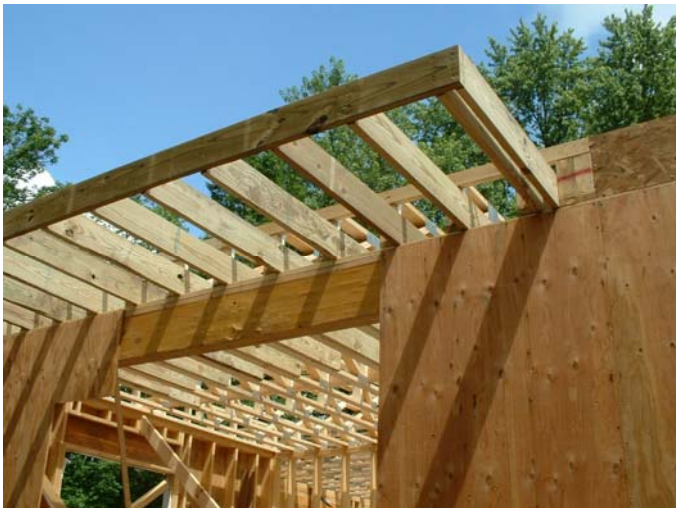
Photo 1 shows the framing for a second-floor deck on a house under construction. The cantilevered beams are dimensional lumber nailed together. Since this deck also serves as a canopy over the French doors on the first floor, it is supported on a beam of laminated veneer lumber (LVL) that is part of a load-bearing wall of 2x6 studs.

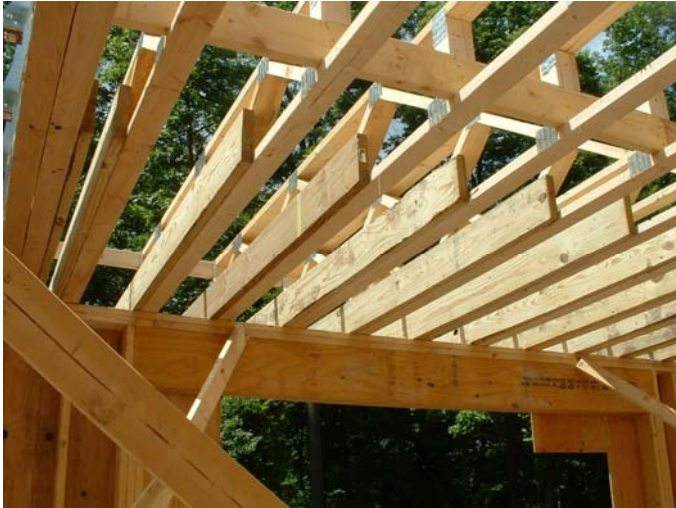
Photo 2 (next page) shows the connection of the cantilevered beams to the parallel-chord wood

floor trusses. Each beam is nailed into both the bottom chord of the truss and into each web member. A construction adhesive was used in addition to the nails, to prevent the nails from loosening in the future and causing the floor to squeak. This system of connection by adhesive and nails was designed by the architect and approved by the truss manufacturer's engineer. Connection of a cantilever to a parallel-chord wood truss is a modification of the truss by building-code definition, since it changes the way in which the truss members react to loads. It requires the approval of the truss designer before the modification is made.

The blueprints show that this system was designed to support a dead load of 15 pounds per square foot and a live load of 50 pounds per square foot, on both the interior floor and on the balcony. Although this may be plenty to support normal furniture and occupants in a bedroom and patio furniture, occupants, and beverages on a balcony, it may not be enough to support the dynamic load of a couple of fully equipped firefighters doing overhaul, especially if heat or fire has involved the trusses or

cantilevers below.

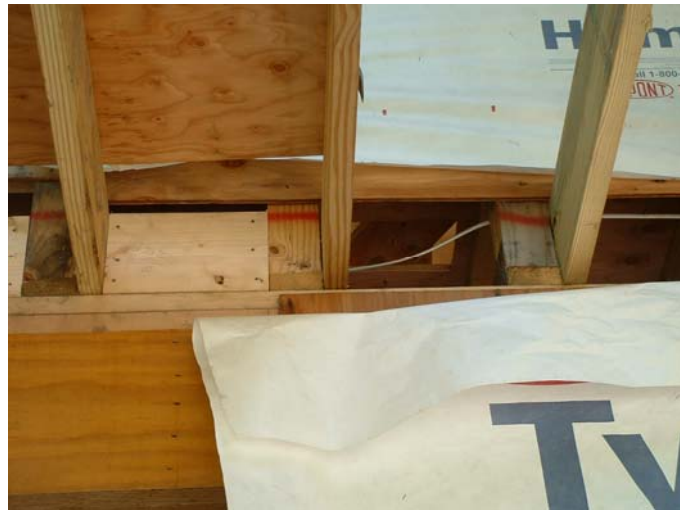
Photo 3 (right) shows the balcony with part of the plywood decking installed and some of the wood blocking installed between the ends of the wood trusses with the cantilever beams attached. Please note that this blocking is not firestopping, since it does not completely fill the opening between the wood joists and the wood trusses, and since it does not protect the ends of the wood trusses. Fiberglass insulation will be added to the inside, and

plywood sheathing will be extended to cover the outside of the building wall. The plywood deck will be completed and plywood paneling will be added to cover the underside of the deck. The connection between this cantilevered deck and the wood trusses will be completely concealed, as will its lack of firestopping.
