# Fire Engineering®

## Construction Concerns: Fire-Resistive Floor-Ceiling Assemblies

Article and photos by Gregory Havel

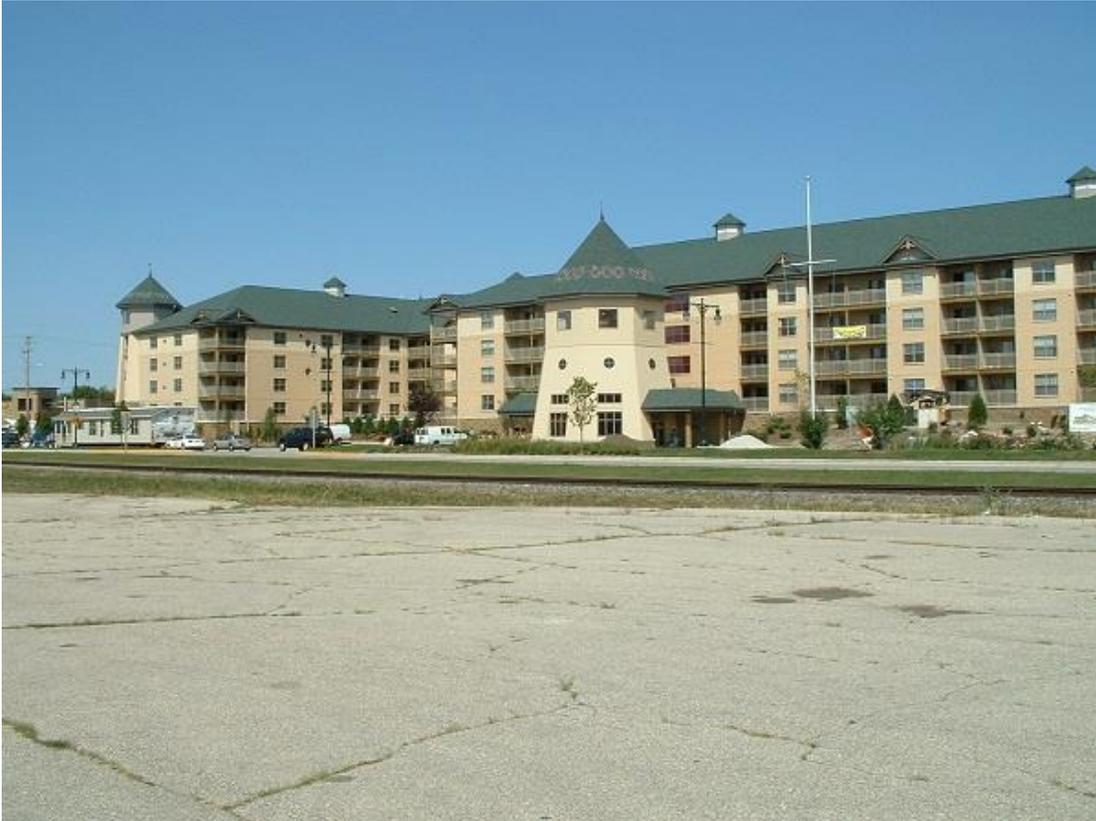
(1)

Photo 1 shows a 172-unit apartment building with four floors of apartments and a parking **garage** at ground level. The parking garage is of noncombustible (Type II) construction separated from the rest of the building by hollow-core, precast concrete panels topped with concrete and is protected by a NFPA 13, Standard

Although the ceiling assemblies in the garages for the apartment buildings in these documents meet current building and fire codes and were built to specifications that should achieve a two-hour fire resistance rating, a vehicle or other fire in the garage in Photo 1 will be less likely to cause structural damage than a vehicle or other fire in the garage in Photo 2 because of the noncombustible materials used to enclose the garage in Photo 1 when compared to the layers of gypsum drywall board used to protect the combustible floor trusses and subfloor in the garage in the building in Photo 3 and Document 1.

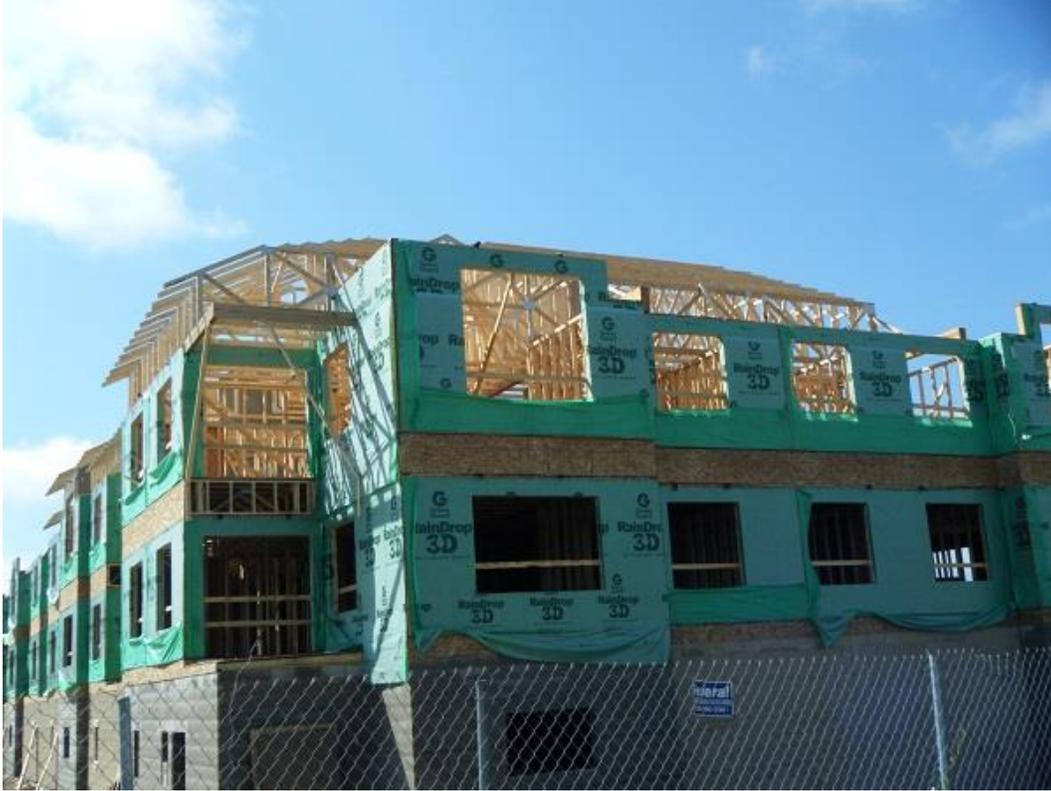
(3)

Photo 3 shows a 24-unit apartment building with two floors of apartments and a parking garage at ground level. The parking garage is of ordinary (Type III) construction and is separated from the rest of the building by a floor-ceiling assembly of oriented strand board supported by wood trusses and supporting multiple layers of 5/8-inch gypsum drywall board, which provides most of the fire resistance for the assembly. This parking garage is protected by an NFPA 13-compliant automatic fire sprinkler system, which protects only the garage space, and not the concealed space between the garage ceiling and the floor of the apartments above. Document 1, from the UL On-Line Fire Resistance Directory, shows an example of the construction of this type of assembly.
